A RENAISSANCE LEANING FAÇADE AT GENOA

WILLIAM HENRY GOODYEAR

OCTOBER, 1902

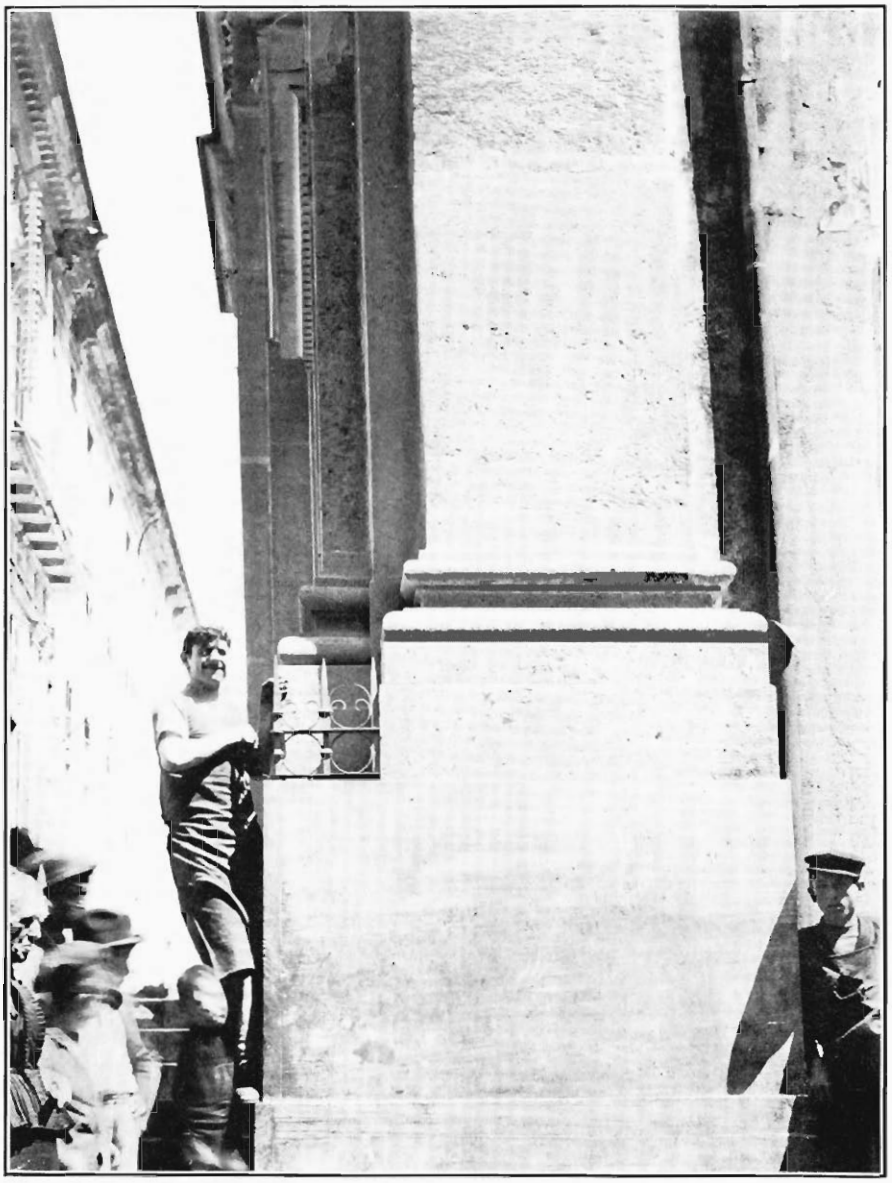
FIG. 1. THE LEANING FAÇADE OF S. AMBROGIO, GENOA.

At the southwest angle, as seen from the side (Fig. 1), the base courses, plinth, and mouldings were noted as level. On the other hand, the pilaster had a slight forward tilt, which appeared to be produced by masonry cutting. The front lower angle of each pilaster block appeared to be slightly obtuse, and the rear angle of each block appeared to be slightly acute (Fig. 1).

Detail showing the oblique cutting of the angle pilaster. Photograph of the Brooklyn Institute Survey, 1901.

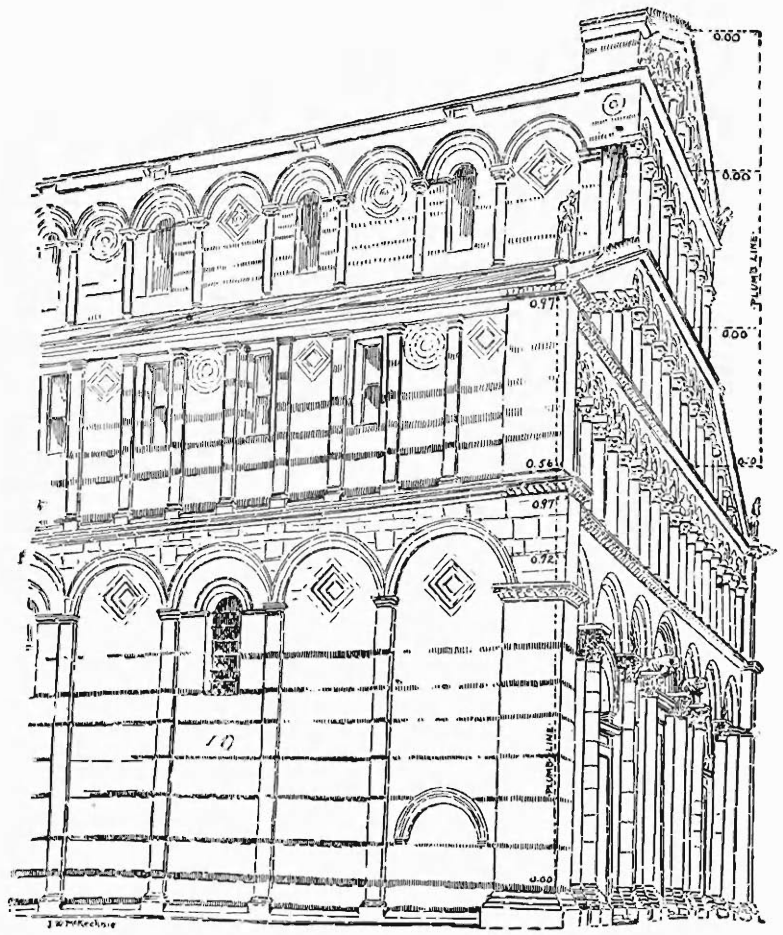
FIG. 4. THE LEANING FAÇADE OF PISA.

Republished from the Architectural Record, Vol. VII., No. 3. Measurements in foot decimals are entered on the drawing. The entire amount of the inclination is about 17 inches, with a return to the perpendicular in the three upper galleries. Tracing from a Brooklyn Institute photograph. See also Figs. 5 and 6.

The whole overhang of the Pisa façade is 17 inches, but it does not project beyond the forward edges of the great plinth blocks at its angles.

It straightens back to the perpendicular in the three upper stories. The third story (second gallery) only tips forward a tenth of a foot, and the two upper stories are perpendicular. This peculiarity of a return bend to the perpendicular is shared by the leaning façades of S. Michele at Pavia (Figs. 7 and 8) and of S. Ambrogio at Milan (Figs. 9 and 10), both of which are undoubtedly constructive. The return curve of S. Ambrogio is shown by Fig. 9, but the return curve of S. Michele (Fig. 8) is mainly above the limits of the photograph. It may be noticed on the left of the picture at the top. An enlargement of the negative up to 25 ″ × 35″, now in the Brooklyn Institute Museum, shows the beginning of the curve quite clearly.

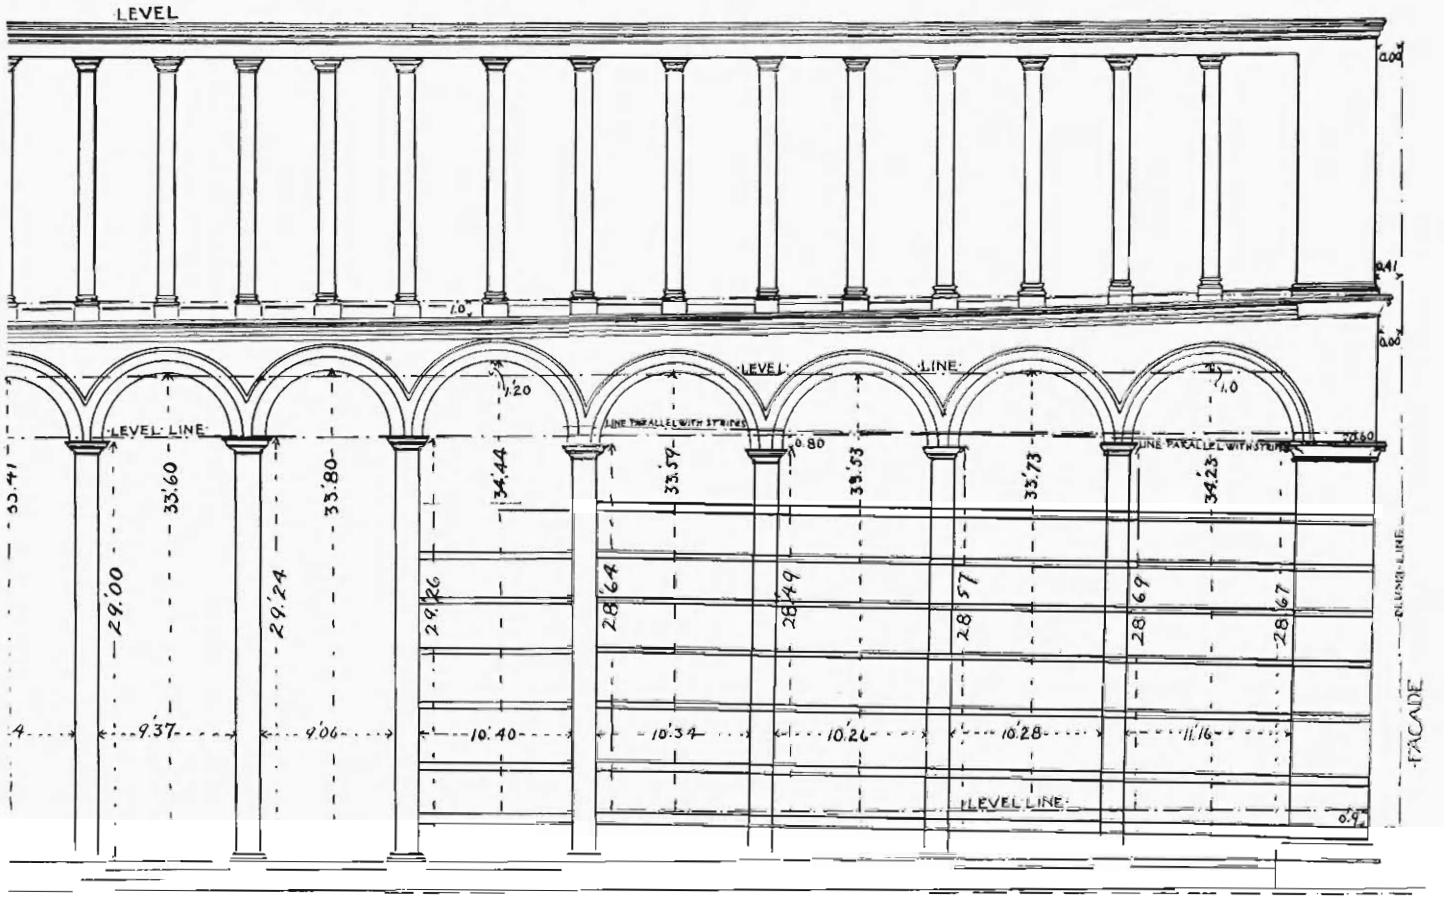
FIG. 5. SURVEY OF THE NORTH CATHEDRAL WALL AT PISA, NEAR THE FACADE.

The measurements and levels show that the bend of the masonry stripes and the connected inclination of the façade are constructive. Measurements in foot decimals. Brooklyn Institute Survey of 1895. Republished from the Architectural Record, Vol. VII., No.

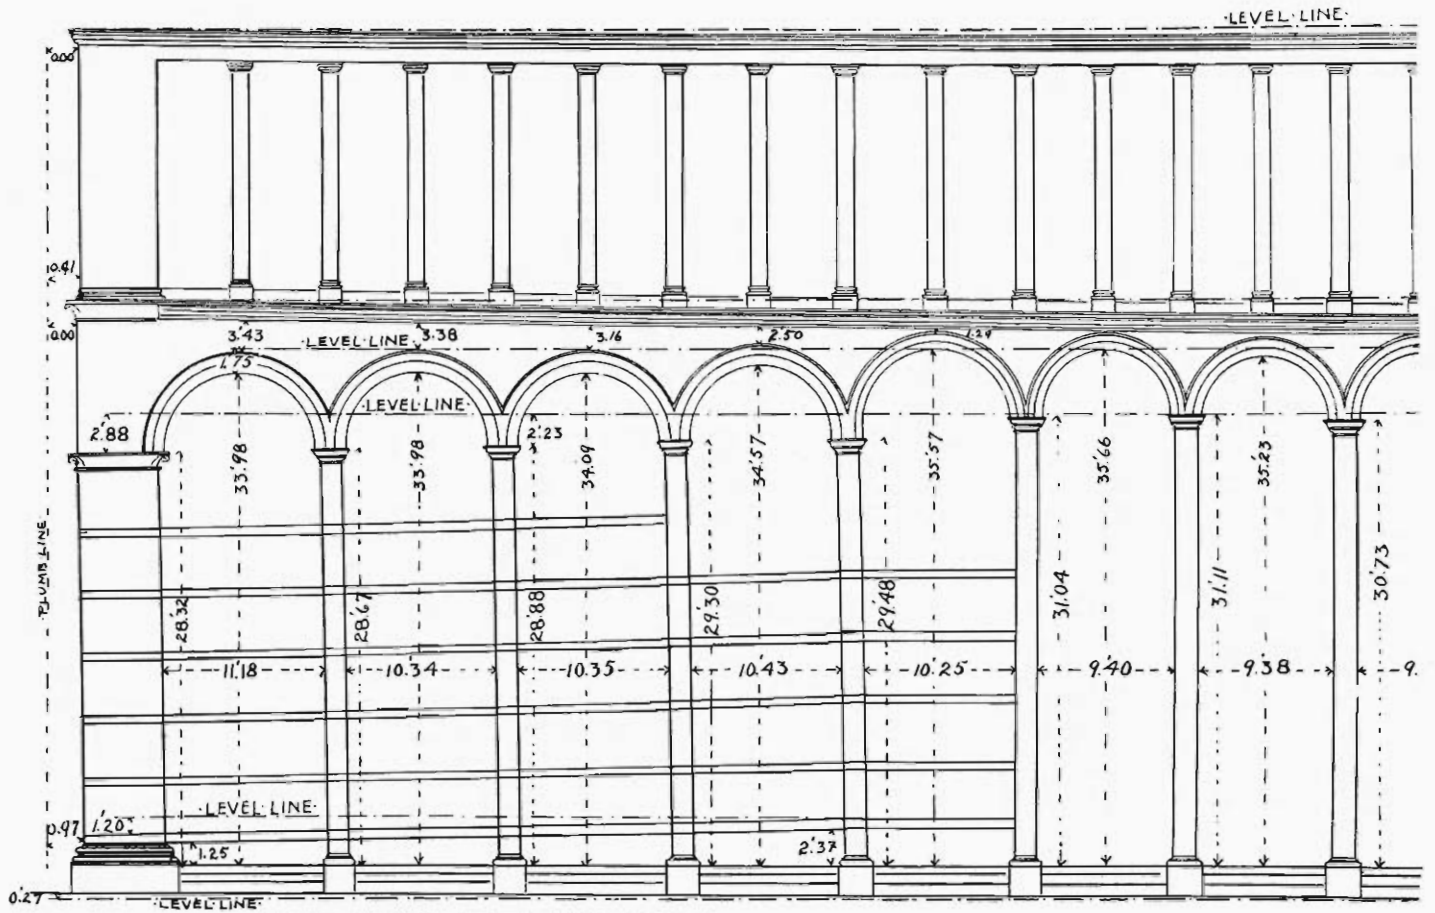
FIG. 6. SURVEY OF THE SOUTH CATHEDRAL WALL AT PISA, NEAR THE FAÇADE.

The measurements and levels show that the bend of the masonry stripes and the connected inclination of the façade are constructive. Measurements in foot decimals. Brooklyn Institute Survey of 1895. Republished from the Architectural Record, Vol. VII., No. 3.

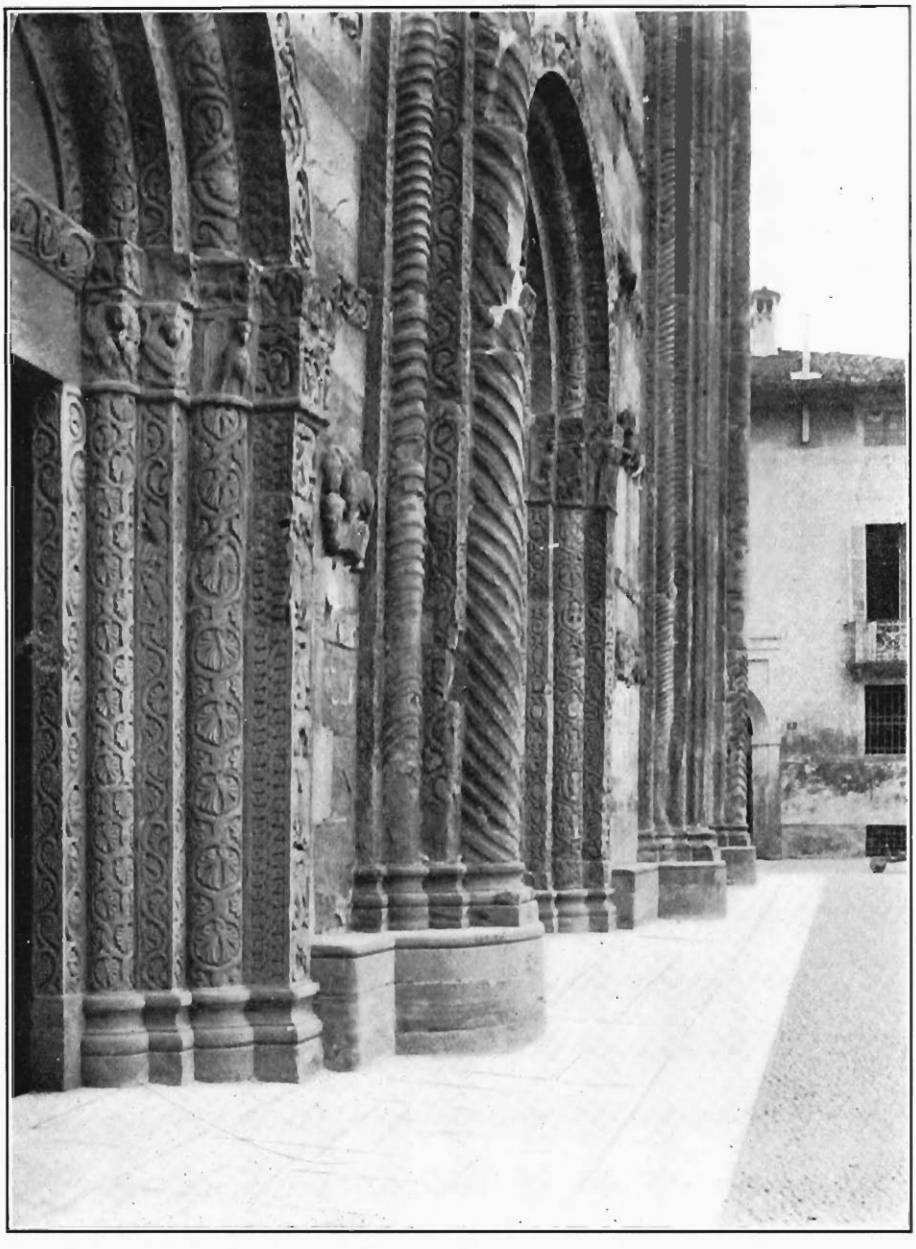
FIG. 7. THE LEANING FAÇADE OF S. MICHELE, PAVIA.

As regards the constructive facts in S. Michele at Pavia, a photograph taken in 1901 is very effective (Fig. 7). It shows an upward tilting of the base courses. These mouldings would dip downward, if the façade had settled.

Detail showing the upward tilt of the plinth mouldings. Photograph of the Brooklyn Institute Survey, 1901.

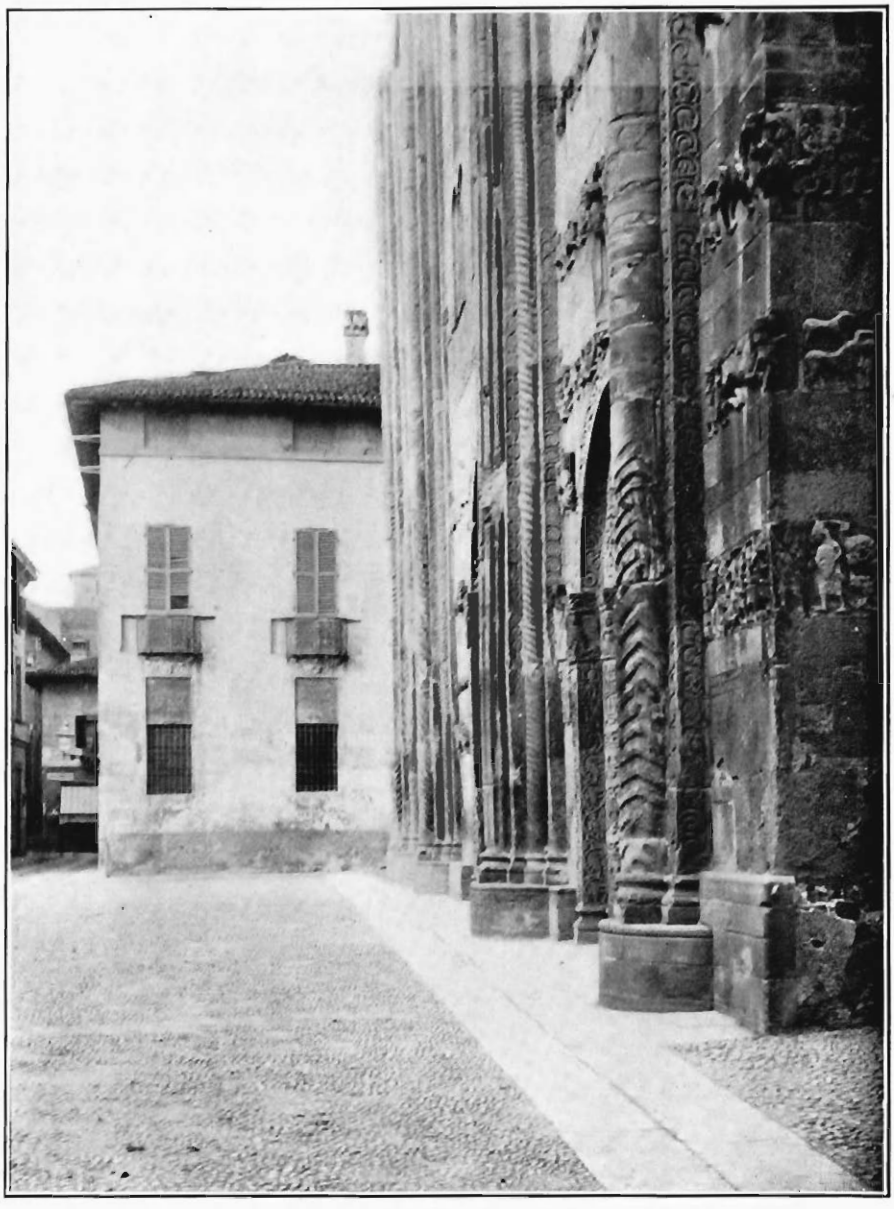
FIG. 8. THE LEANING FAÇADE OF S. MICHELE, PAVIA.

The inclination is about a foot, with return bend to the perpendicular, which shows slightly on the extreme left. Photograph of the Brooklyn Institute Survey, 1901.

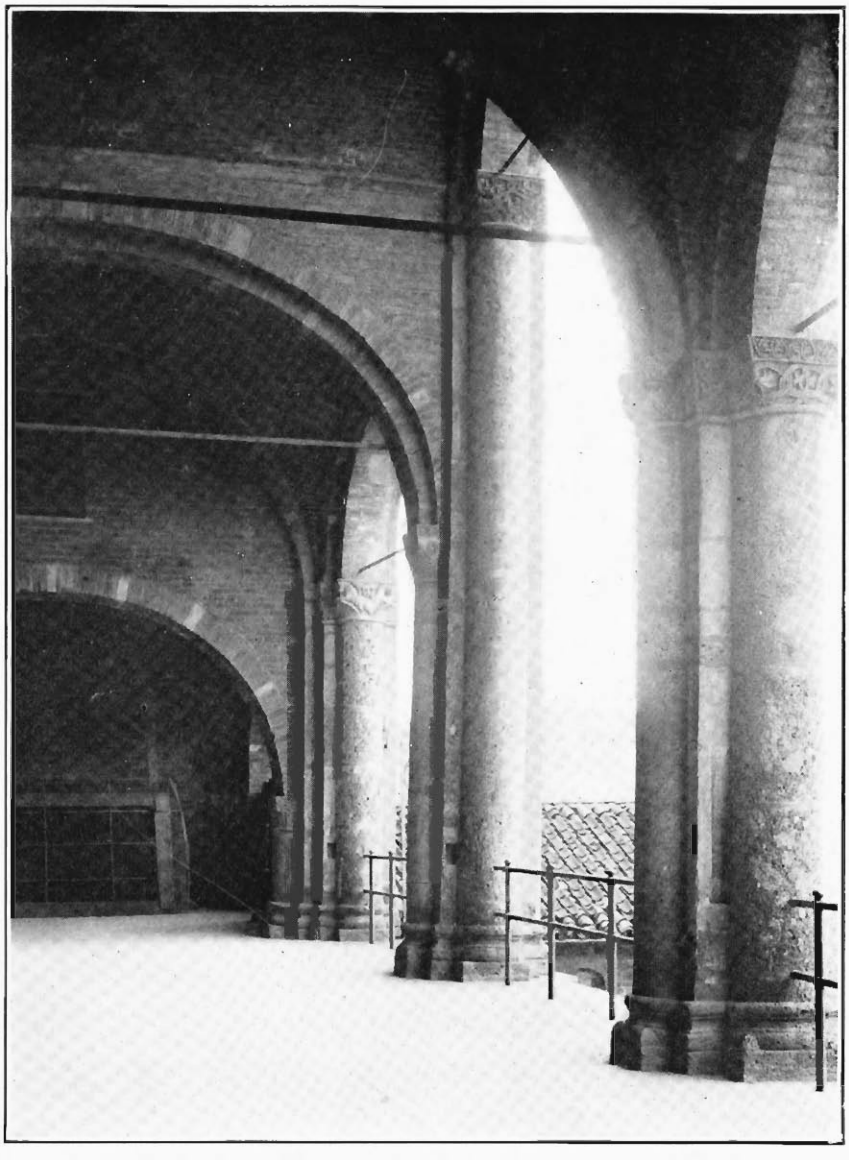
FIG. 9. RETURN CURVE OF THE LEANING FAÇADE OF S. AMBROGIO, MILAN.

In Fig. 9, the return curve of S. Ambrogio at Milan is shown from the inside of the portico (second story) as being against thrust. As the return curve is constructive, of course the lean must be the same (Fig. 10). This lower façade thrusts against court arcades of the same date and is supported by them. The capitals of the piers have been observed as horizontal, although the picture does not show this. If the façade had settled, the tops of the capitals would dip downward. There is also conclusive evidence in the masonry cutting so far unpublished.

Taken inside the portico of the second story. Photograph of the Brooklyn Institute Survey, 1901.

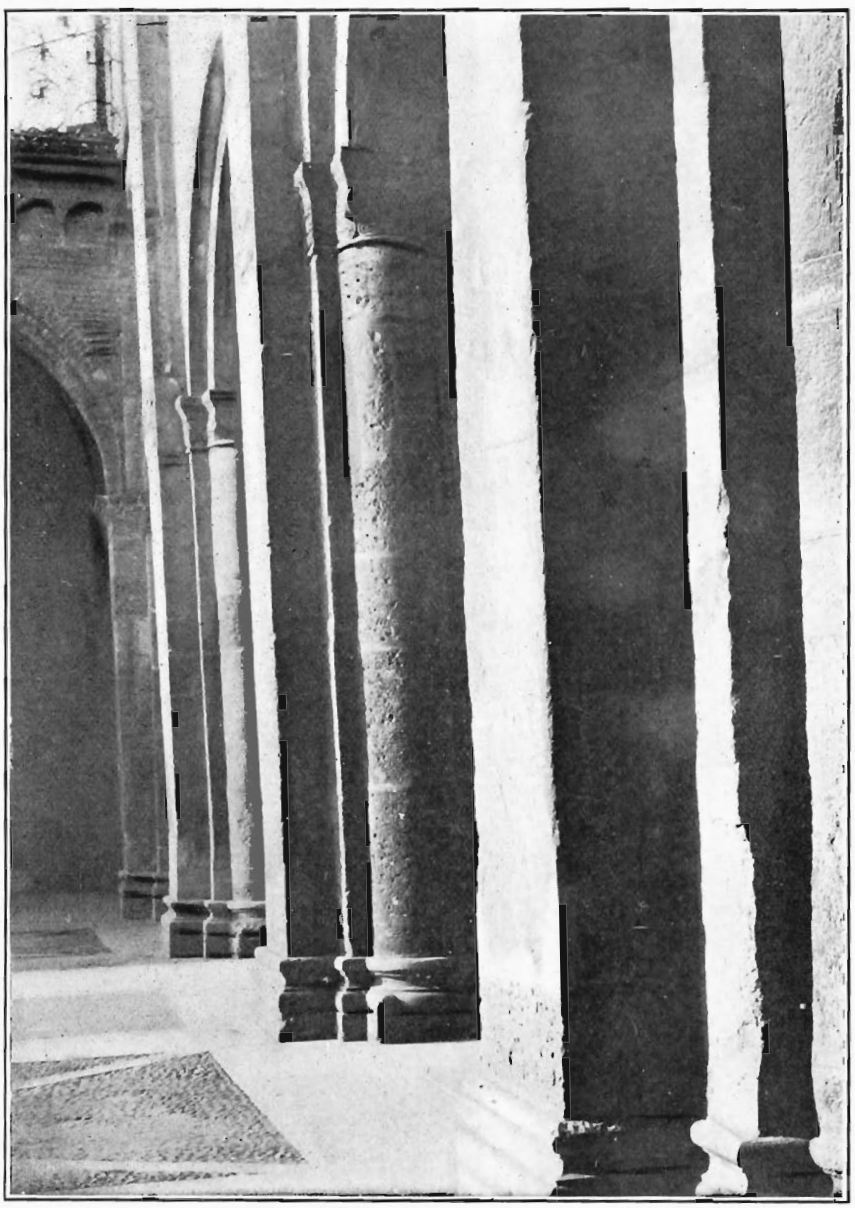
FIG. 10. THE LEANING FAÇADE OF S. AMBROGIO, MILAN.

The lean amounts to 9 inches for the first story. Photograph of the Brooklyn Institute Survey, 1901.

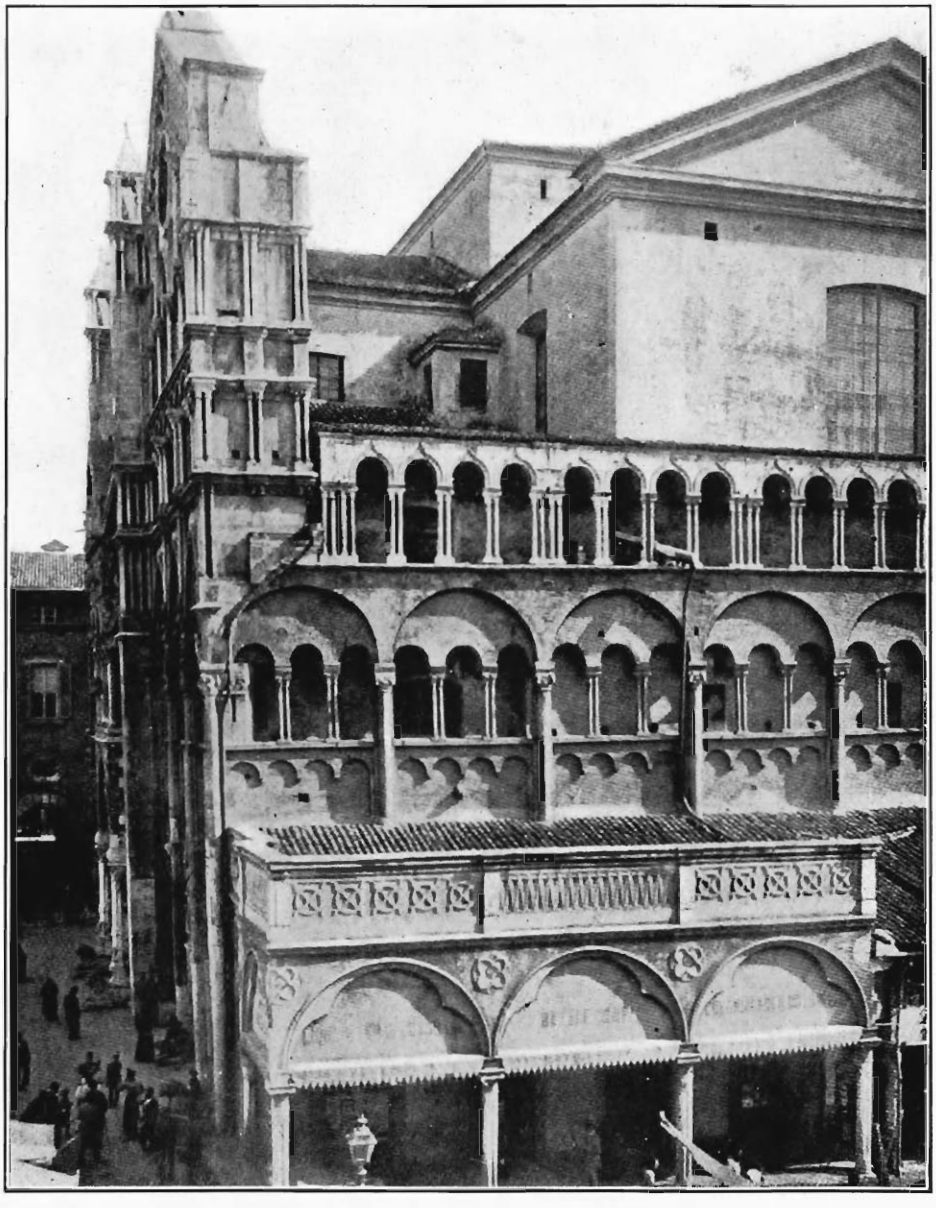
FIG. 11. THE LEANING FAÇADE OF FERRARA.

The leaning façade of the Ferrara Cathedral has already been noticed and illustrated in the Architectural Record.* This is the one important mediæval instance, so far observed, which shows a continuous forward lean (Fig. 11), as distinct from a return bend. There are no partings of the masonry on the sides, such as would have occurred if the foundations of the building had yielded. The amount of this lean appears to be about 22 inches in about 96 feet

The lean amounts to about 22 inches in 96 feet. Photograph of the Brooklyn Institute Survey, 1901.

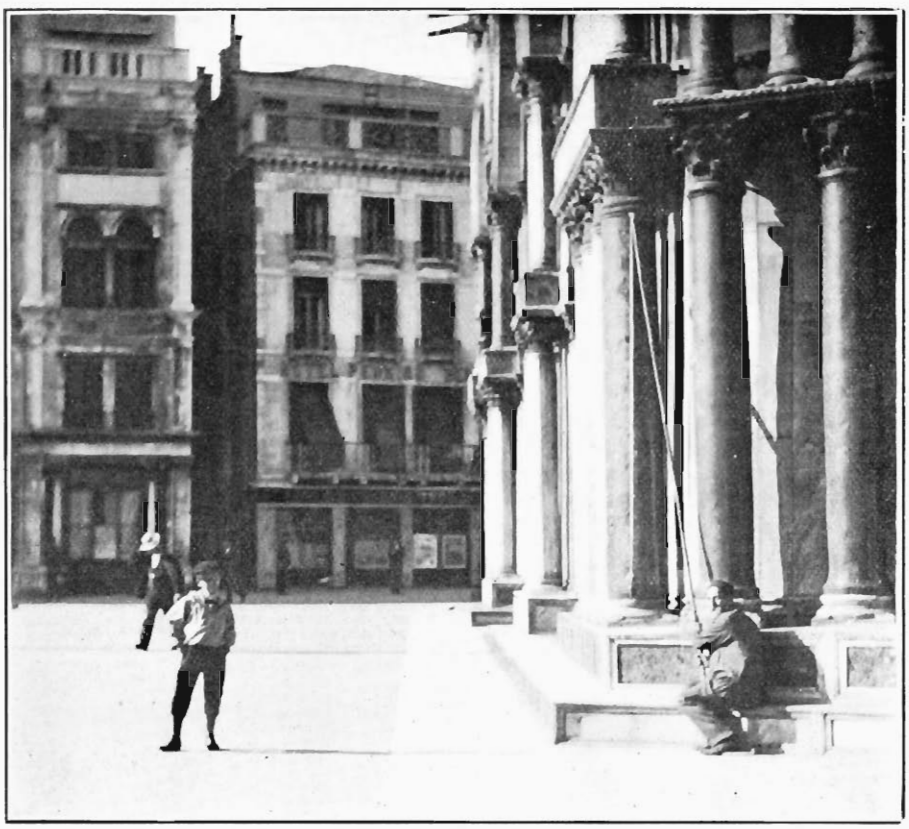
FIG. 12. THE LEANING COLUMNS OF S. MARK'S FAÇADE, VENICE.

All the columns of the façade of S. Mark's on the lower story, lean out in similar fashion, excepting those at the southwest angle, which have been repaired by an architect now deceased, and ignorant of this refinement. The plumbs show tips varying from 2¼ to 3½ inches in a height of 9½ feet. The walls behind these columns are perpendicular. The columns of the upper row are perpendicular.

The leans vary from 2¼ to 3½ inches in a height of 9½ feet. The upper columns are perpendicular, as is the wall behind the leaning columns. Photograph of the Brooklyn Institute Survey, 1901.

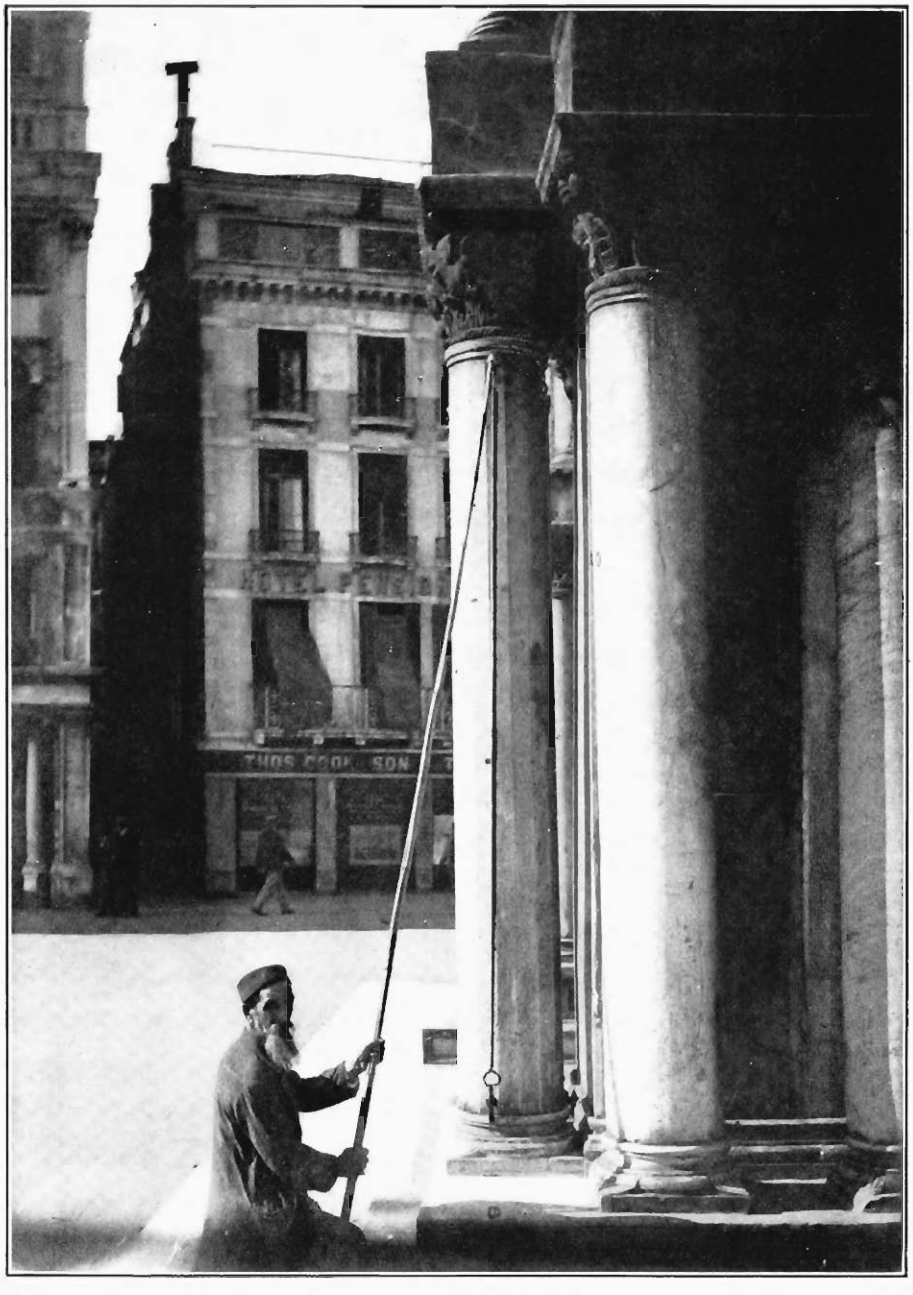
FIG. 13. THE LEANING COLUMNS OF S. MARK'S FAÇADE, VENICE.

The leans vary from 2¼ to 3½ inches in a height of 91½ feet. The upper columns are perpendicular, as is the wall behind them. Photograph of the Brooklyn Institute Survey, 1901.
